DEPARTMENT OF TRANSPORTATION**DIVISION OF ENGINEERING SERVICES**

Office of Structural Materials

Contract #: 04-0120F4Cty: SF/ALA Rte: 80 PM: 13.2/13.9File #: 1.28**WELDING INSPECTION REPORT****Resident Engineer:**Siegenthaler, Peter**Address:** 333 Burma Road**City:** Oakland, CA 94607**Report No:** WIR-018517**Date Inspected:** 08-Dec-2010**Project Name:** SAS Superstructure**OSM Arrival Time:** 1000**Prime Contractor:** American Bridge/Fluor Enterprises, a JV**OSM Departure Time:** 1830**Contractor:** American Bridge/Fluor Enterprises, a JV**Location:** Jobsite**CWI Name:** See below**CWI Present:** Yes No**Inspected CWI report:** Yes No N/A**Rod Oven in Use:** Yes No N/A**Electrode to specification:** Yes No N/A**Weld Procedures Followed:** Yes No N/A**Qualified Welders:** Yes No N/A**Verified Joint Fit-up:** Yes No N/A**Approved Drawings:** Yes No N/A**Approved WPS:** Yes No N/A**Delayed / Cancelled:** Yes No N/A**Bridge No:** 34-0006**Component:** SAS OBG**Summary of Items Observed:**

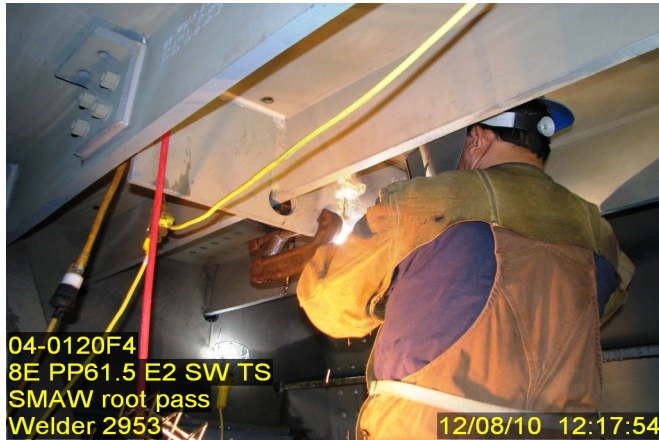
4). OBG East Line Access Penetration Insert Transverse Stiff. (TS) Splice at 8E PP61.5 E2 SW

The QAI periodically observed AB/F approved welder Wai Kitlai (ID 2953) performing root, fill and cover pass welding per the Shielded Metal Arc Welding (SMAW) process in the 3G (vertical) position on the West face of OBG East Line Access Penetration Insert TS Splice at 8E PP61.5 E2 SW. See photo below. QC Inspector John Pagliero was present to monitor the progress and verify that the welding parameters were within the limits established by the approved welding Procedure Specification (WPS) identified as ABF-WPS-D1.5-1010 rev 1. Cover pass welding was completed on the West face and the QAI periodically observed welder 2953 performing back grinding on the East face. The QAI observed the work at this location appeared to be in general compliance with contract documents.
